HOME INSPECTION REPORT

305 Carnaby St., Stafford, VA 22554

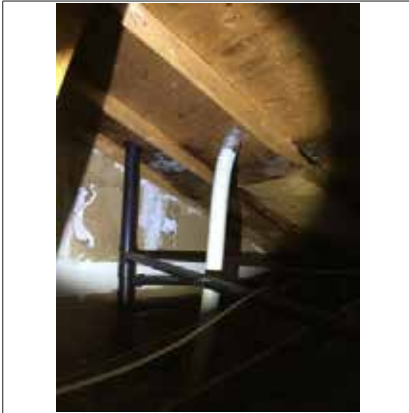
B. Ask about the age of the shingles. Sheathing is stained and discolored appears to be an active leak from attic view. Have a roofer check and estimate cost for roof repairs.

Sheathing discoloration and stained

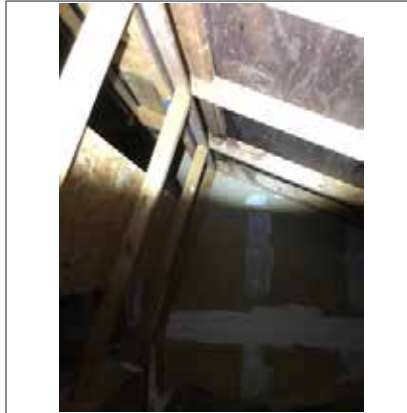
Sheathing discoloration

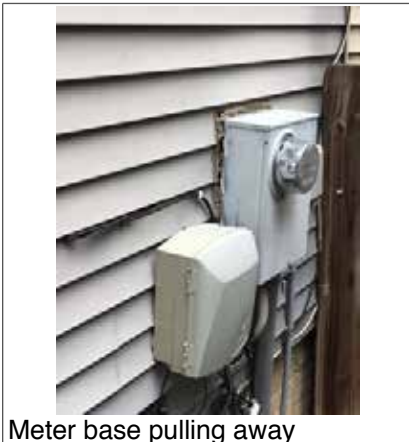
Electrical: A. The electrical meter base is pulling away from the house and needs to be repaired.

Meter base pulling away

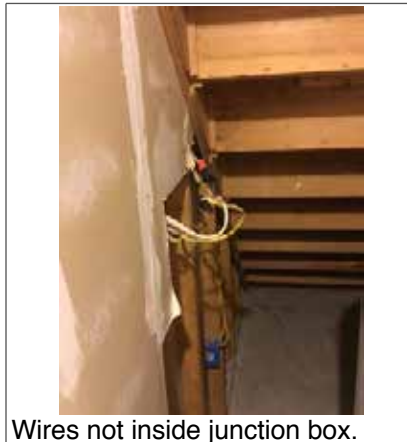
B. Have the electrician check the wires next to water heater not inside a junction box coming off outlet on wall.

Wires not inside junction box.

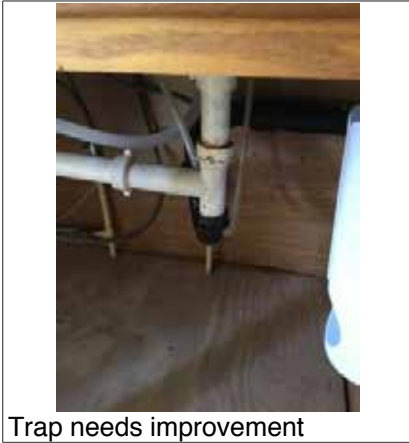
E. Waste pipe under kitchen sink is not to code, slip joint needs to be extended.

Trap needs improvement
