HOME INSPECTION REPORT

305 Carnaby St., Stafford, VA 22554

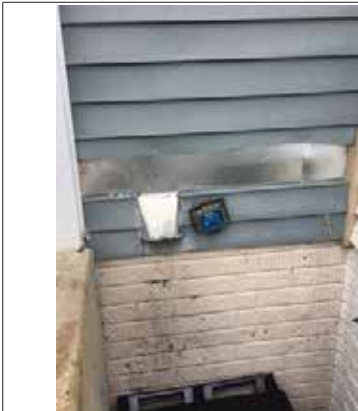
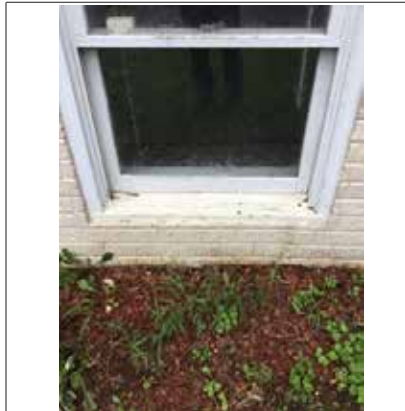
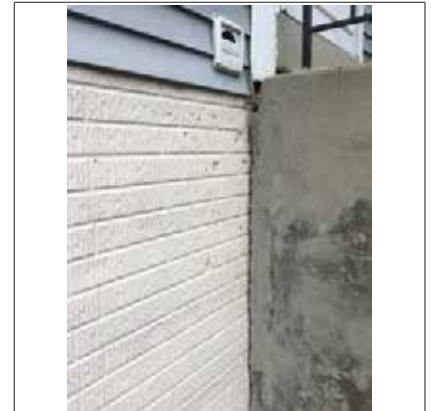
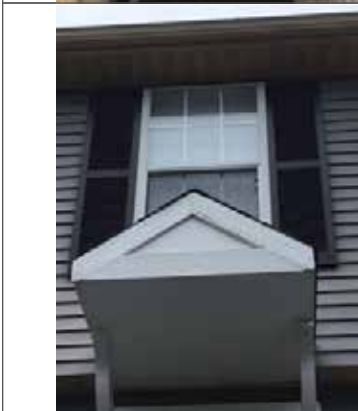
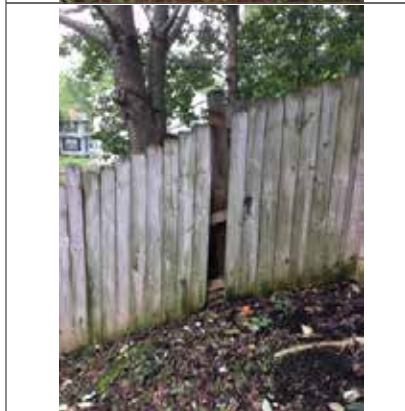
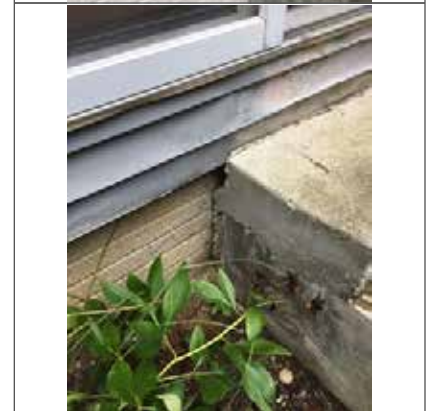
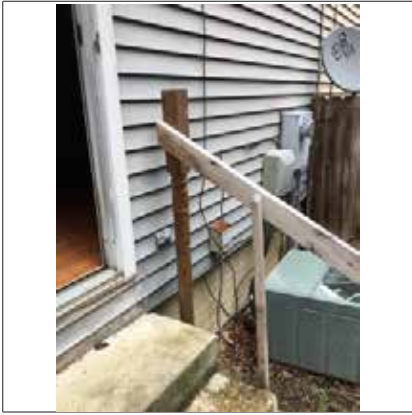
Exterior: A. Front steps pulling away from the house, repair as needed.

B. Louver vent broken front of house, needs to be replaced.

C. Window sill front basement rotted and needs to be replaced along with the window.

D. Siding missing right side of front door. Repair as needed.

E. Portico above front door is rotted needs repair and paint.

F. Stairs back of house need to be replace with railing. The steps have dropped below the 8 1/4 max riser height.

G. Repair fence as needed, missing pickets.
